McKee Home Inspection Services

Property Inspection Report

28885 Buck Owens blvd, Bakersfield CA, 93308
Inspection prepared for: Buck Owens
Agent: -

Inspection Date: 6/12/2009 Time: 10:00 am
Age: 8 years old Size: 3800 s.f.
Weather: about 95 deg

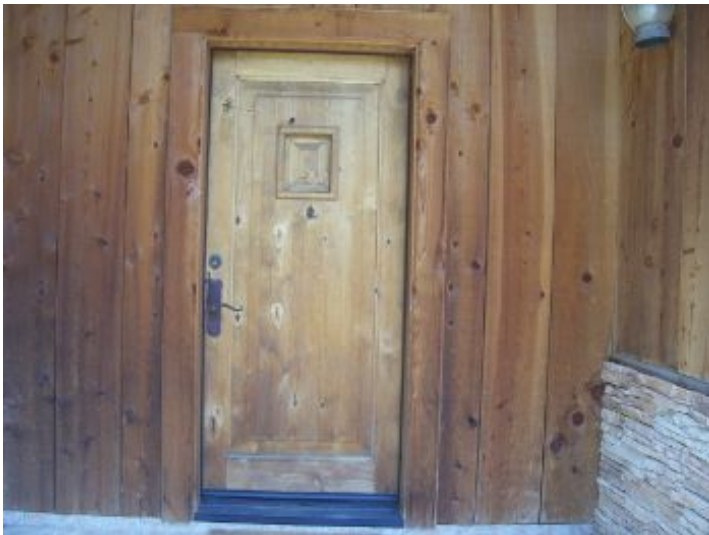
Front door needs a protective coat of varnish.

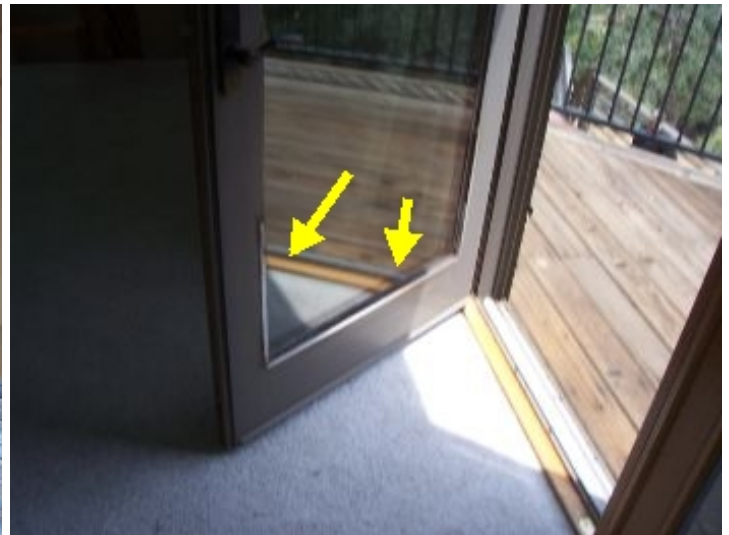
master french door shows signs of repair

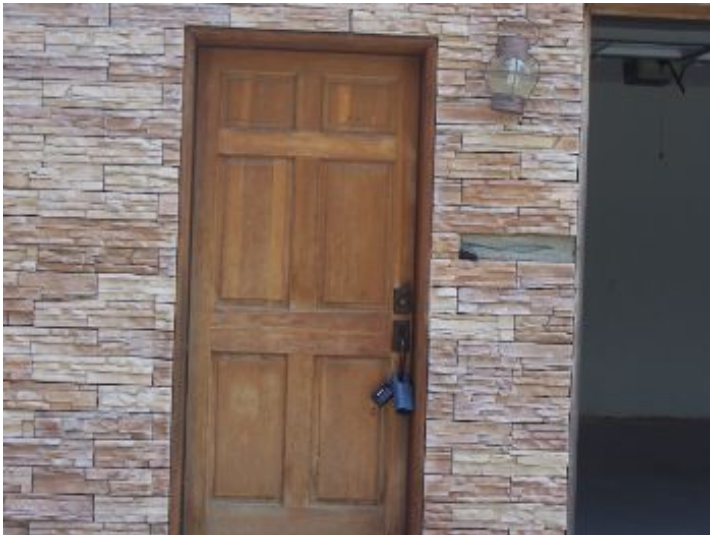
garage man door needs to be varnished

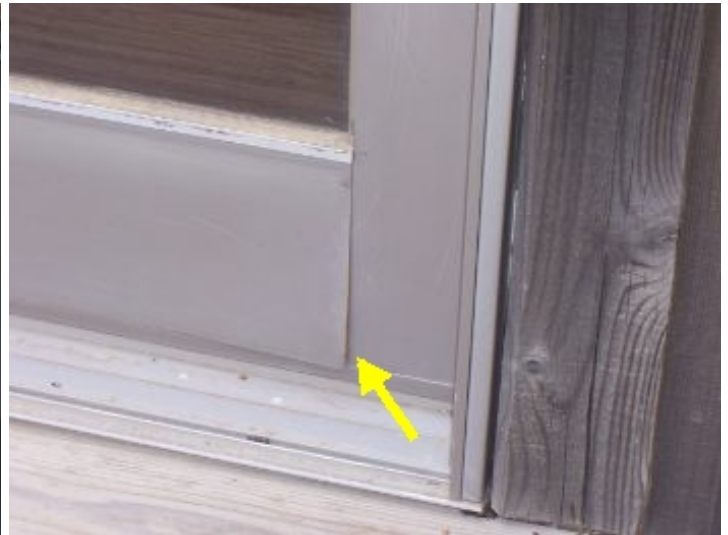
- Front door needs a protective coat of varnish.
- Front door needs an adjustment, latch and striker plate rub.
- Metal clad on the out side at the bottom of the sliding door south of fireplace is coming loose.

metal clad coming loose

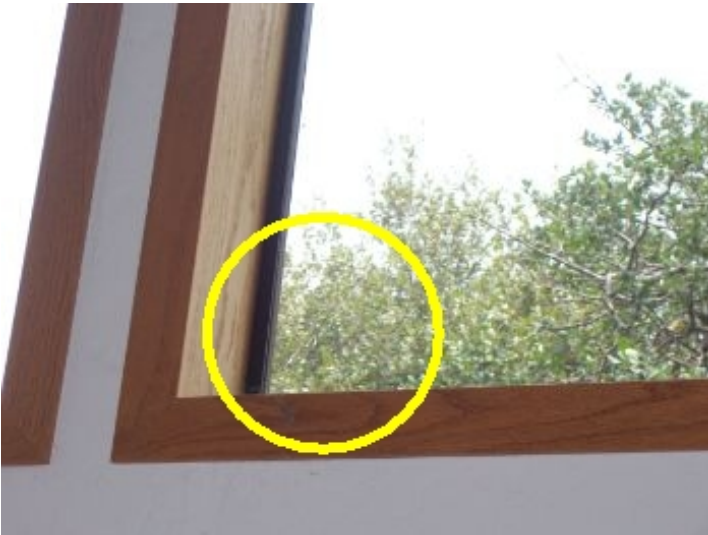
Great room cracked glass

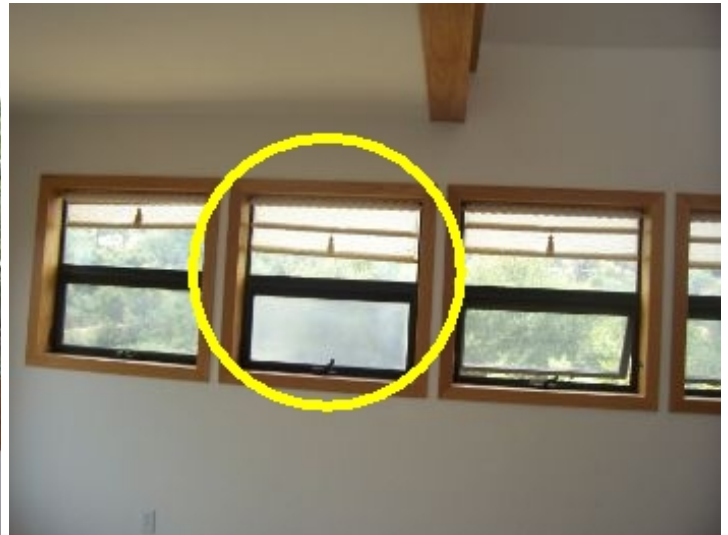
window is fogged

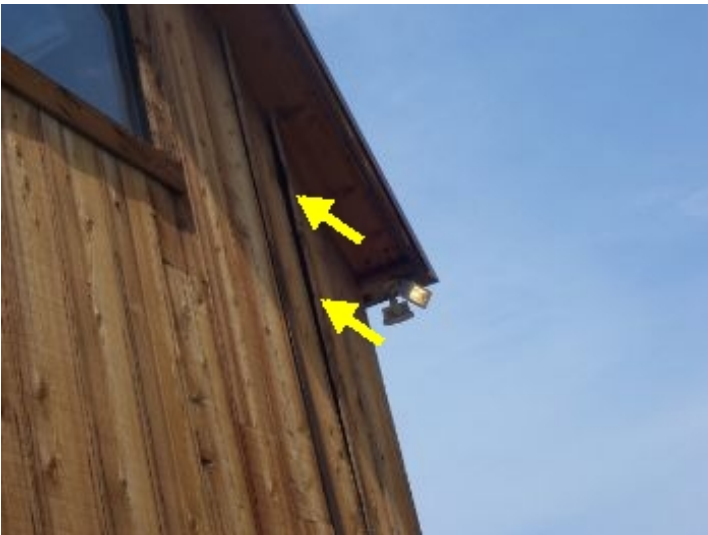
Observations: Stone Veneer is coming off at various locations on the house. Recommend re-attaching all loose and fallen stones as needed, by a qualified licensed contractor. , Cedar siding has numerous wood pecker holes throughout, loose in many places around the house and overhang. Recommend replacement or repair by a qualified licensed contractor.

boards coming loose

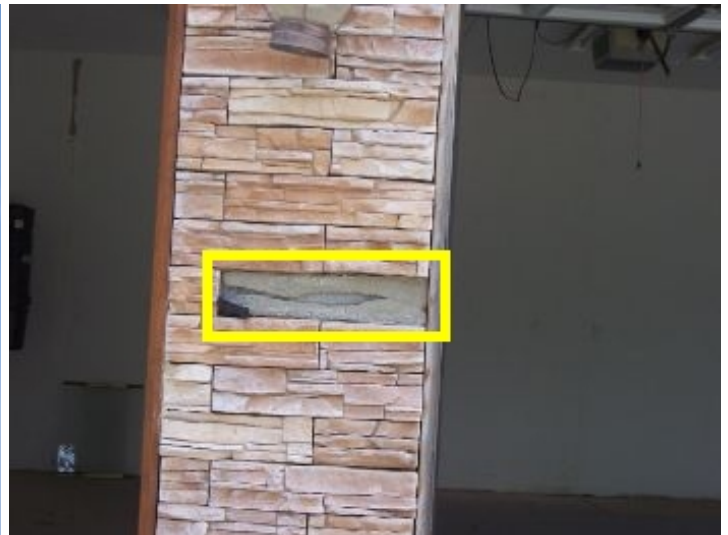
missing stone

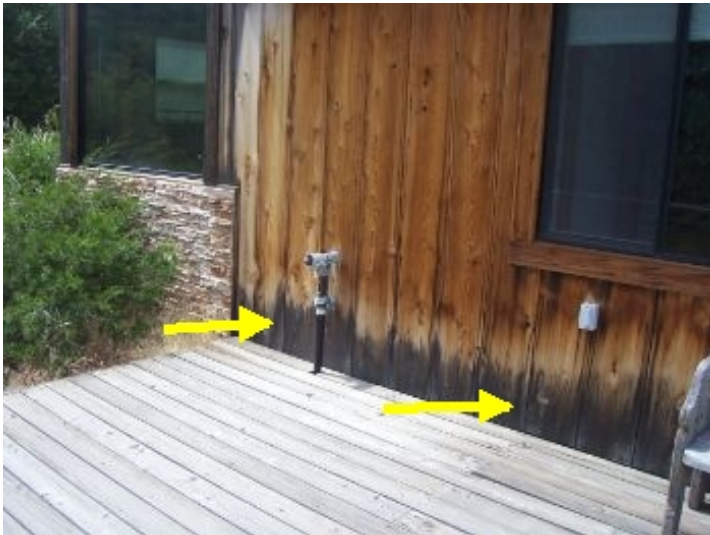
weathered siding

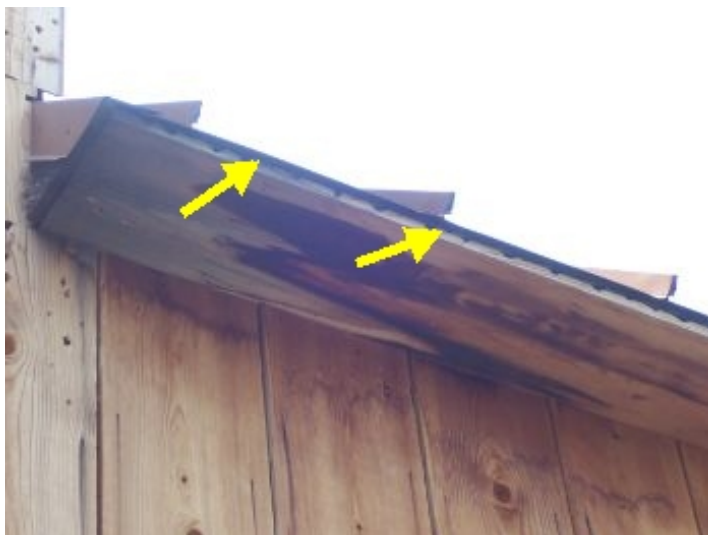
missing drip metal

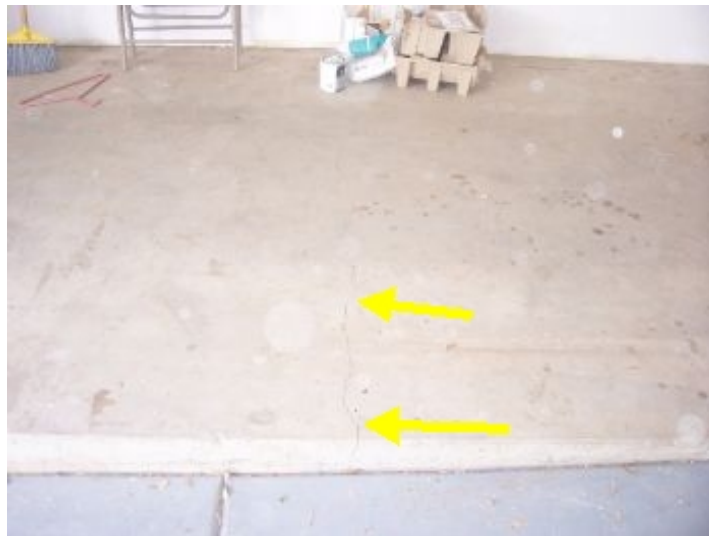
Common cracking noted

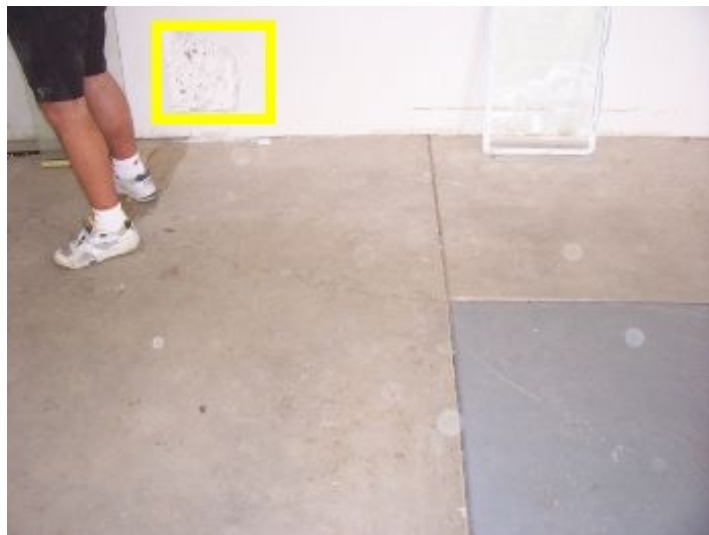
Damaged drywall on back wall lower left side.

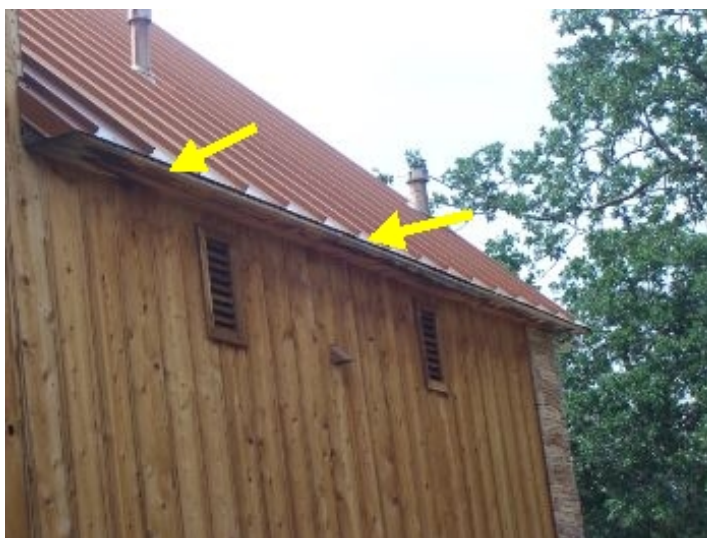
Observation: No drip metal at both side of garage, and also at various locations around the eaves. • We recommend correcting the condition(s) noted using approved methods.

no drip metal

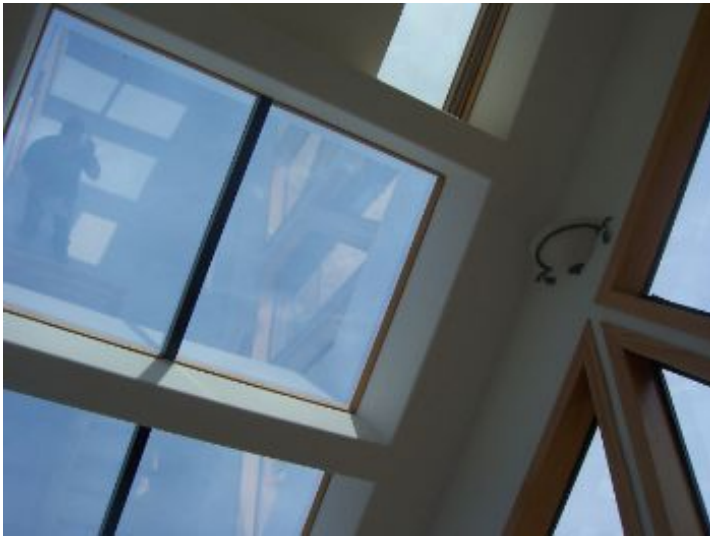
Cracked skylight

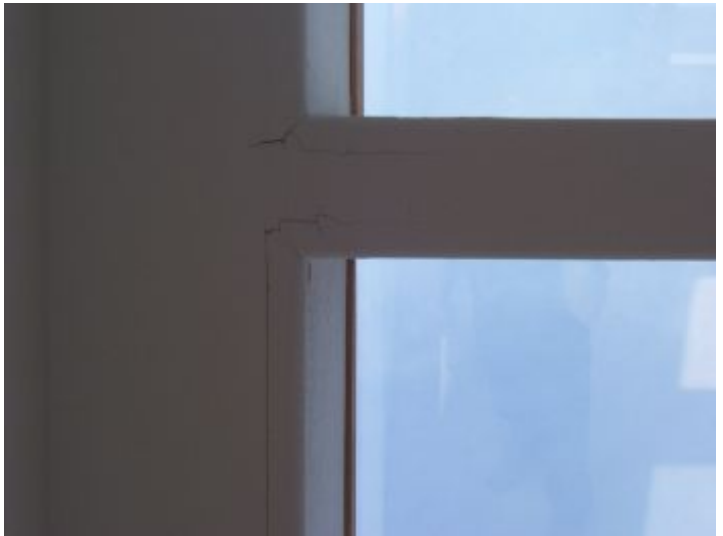
water leaks from skylight in master bedroom

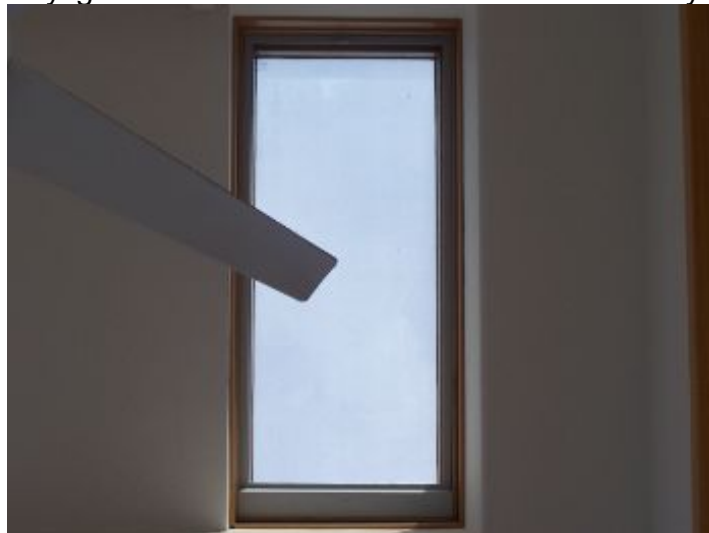
Velux skylight would not open

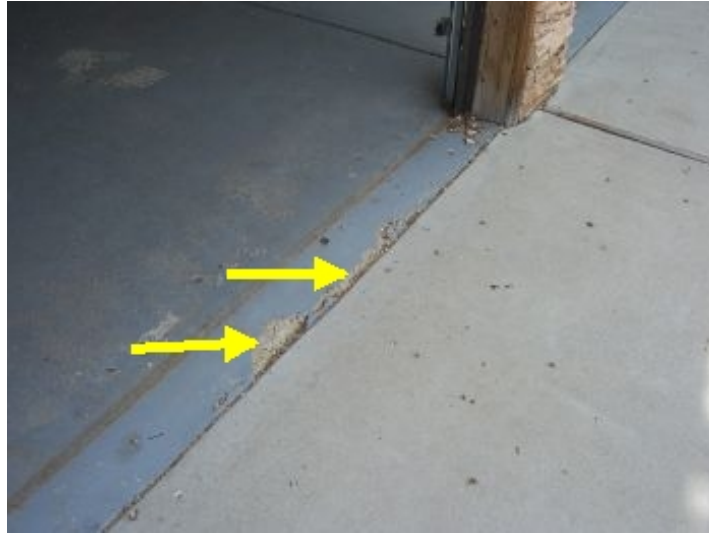
Common cracks noted.

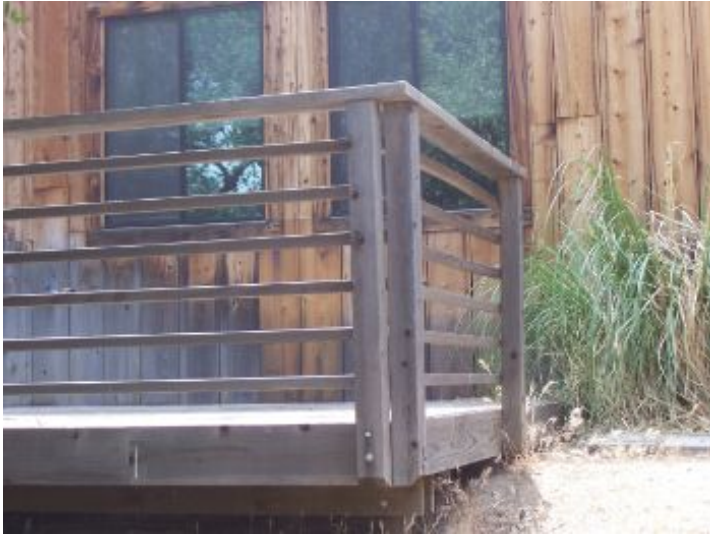
loose hand railing

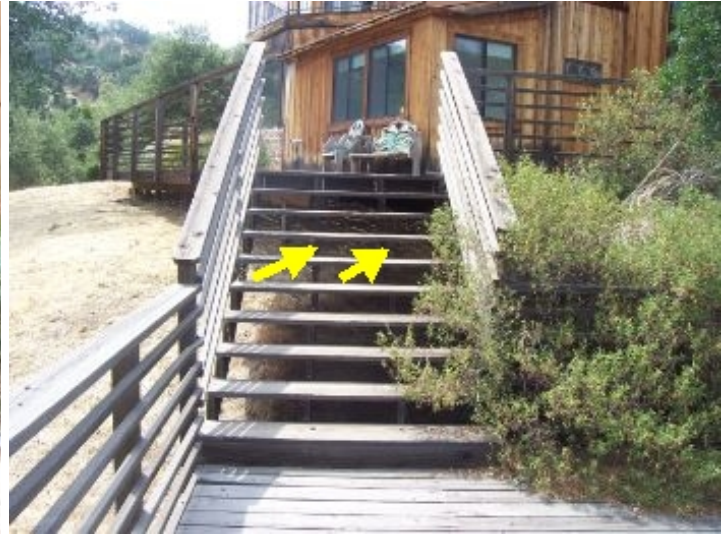
stairs need support

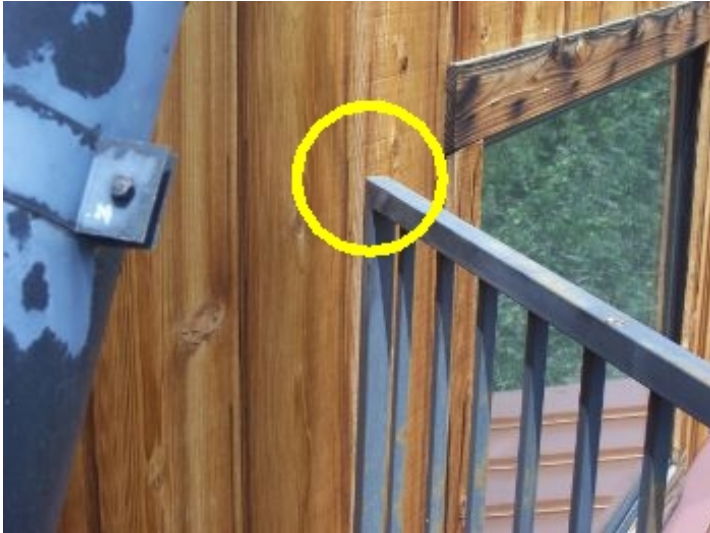
handrail is loose at wall

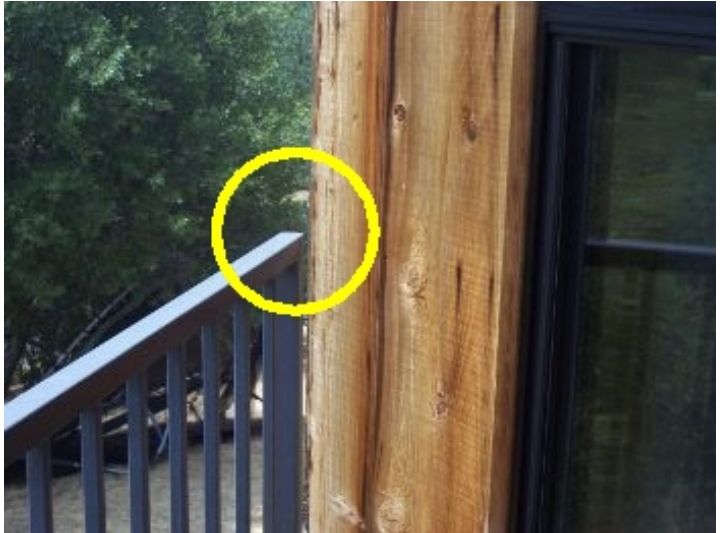
handrail is loose at wall

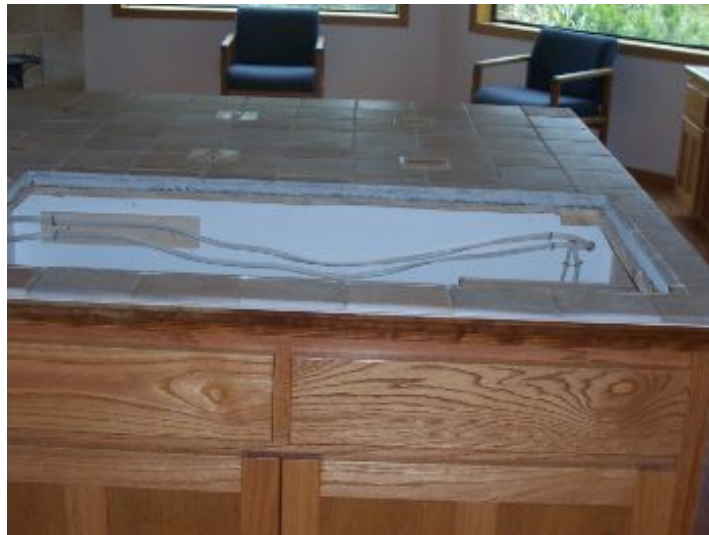
Observations: Cook Top, is missing

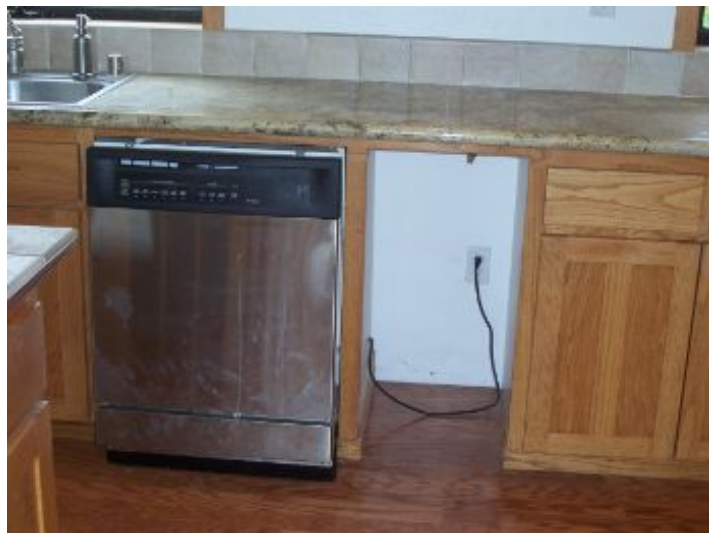
Observations: Trash compactor is missing.

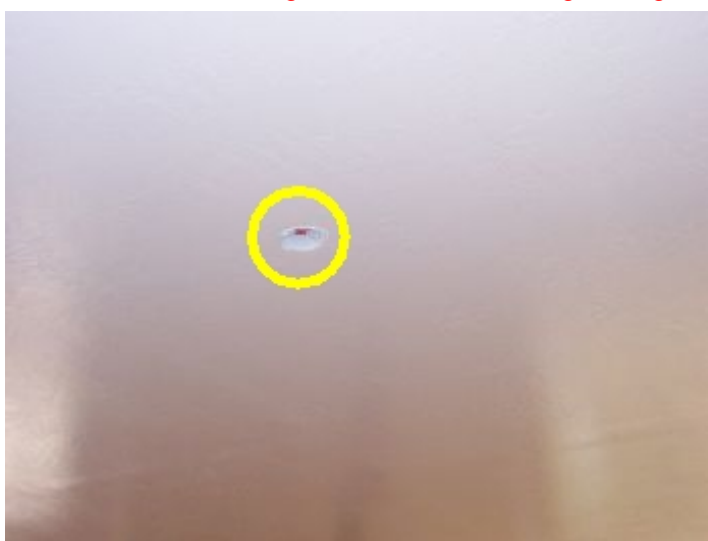
Light above Kitchen island is missing. Recommend installing new light or protective blank cover.

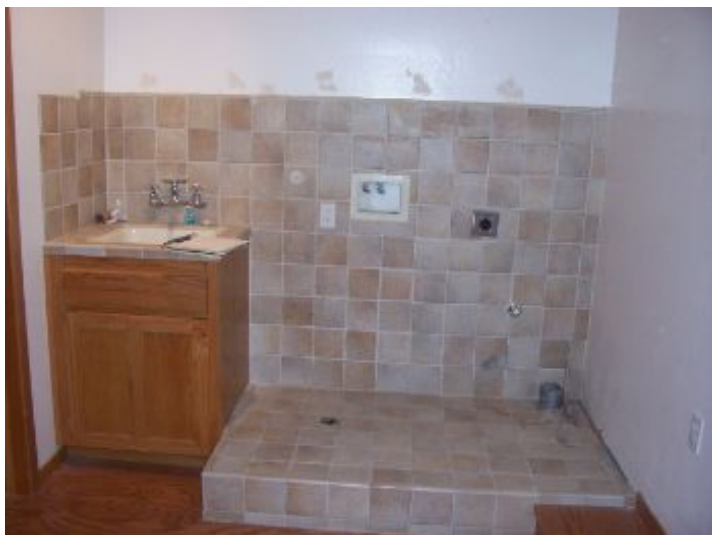
missing upper cabinets

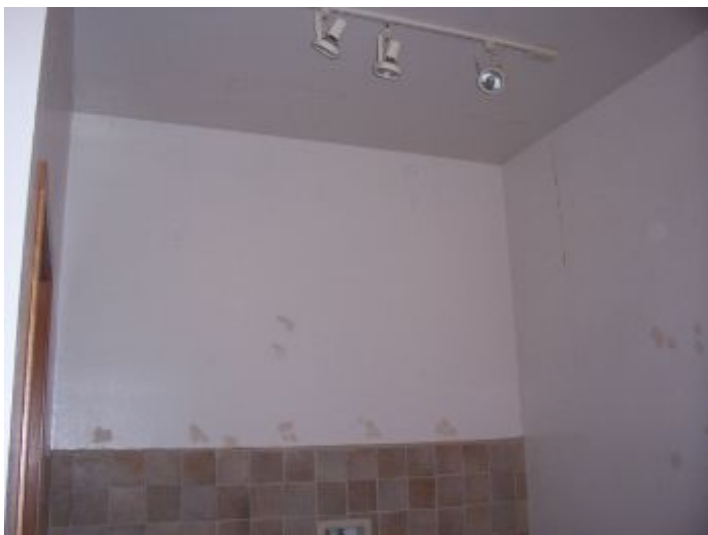
Upper wall Cabinets have been removed.

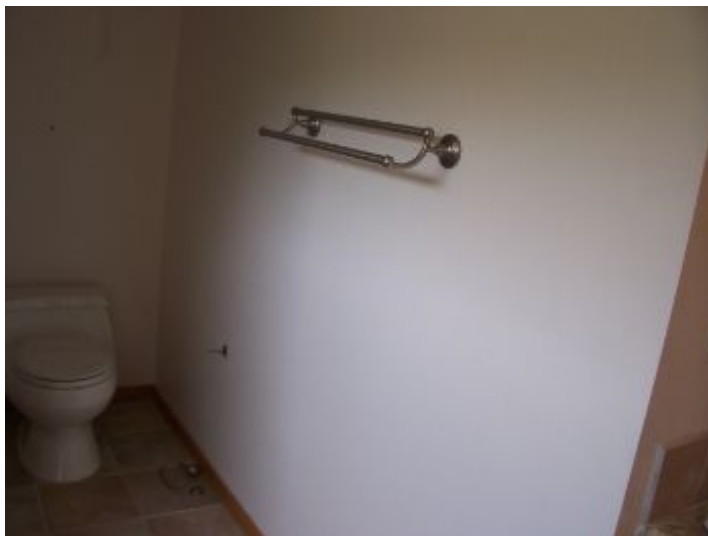
loose towel and toilet paper holder

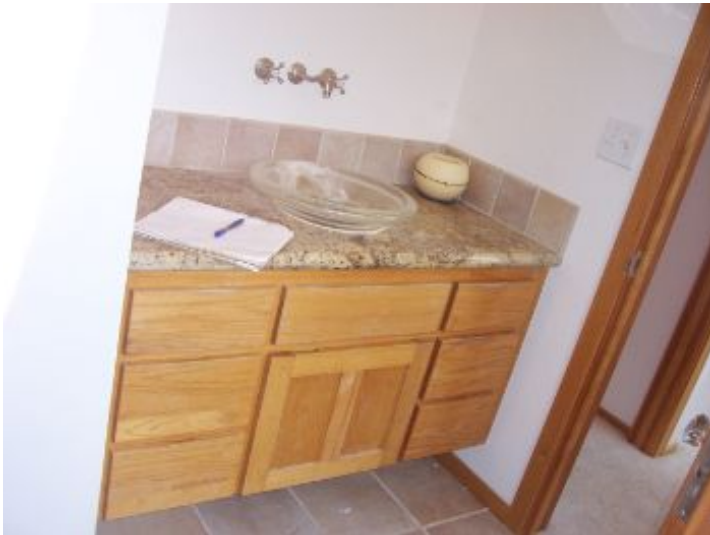
cabinets need varnish

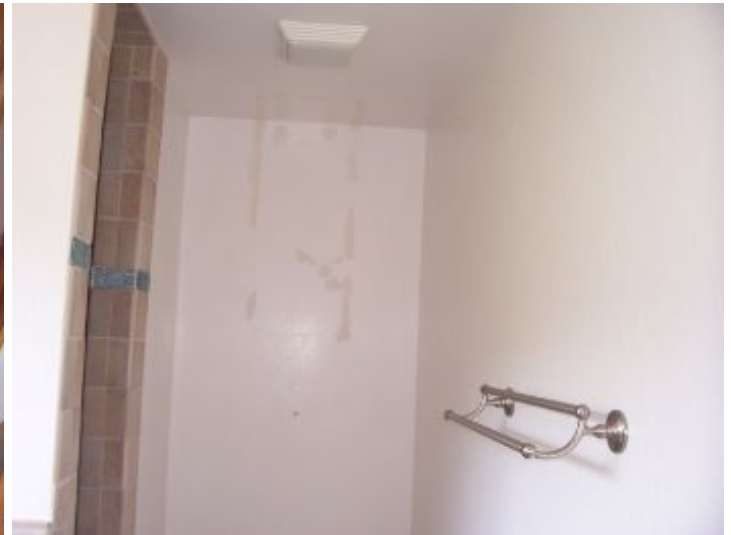
Cabinet is missing above toilet in water closet.

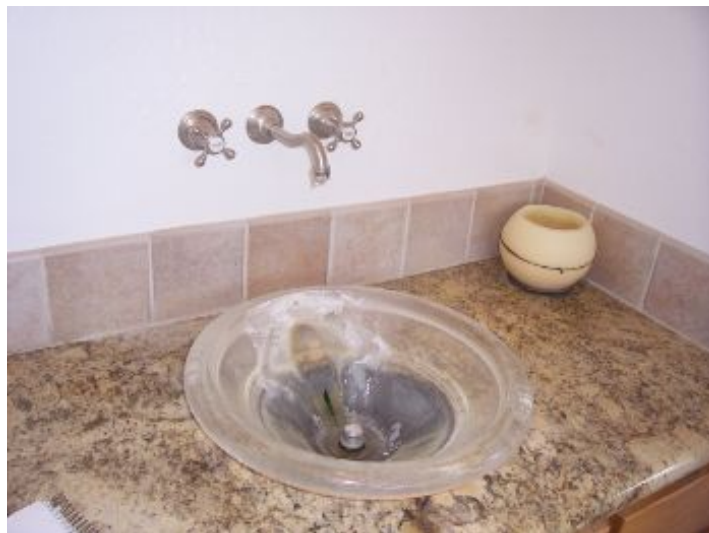
Observation Faucet is, leaking, Recommend review for repair or replacement as necessary by a Licensed plumber.

faucet leaks

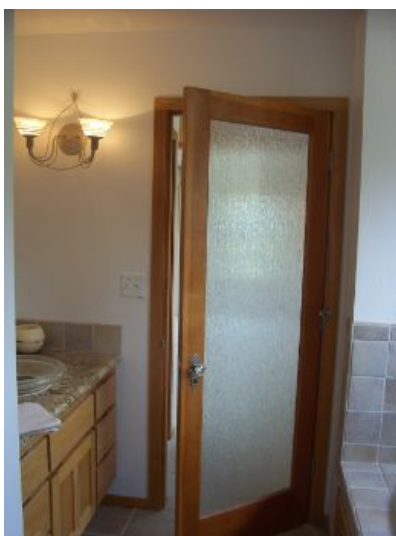
door needs varnish

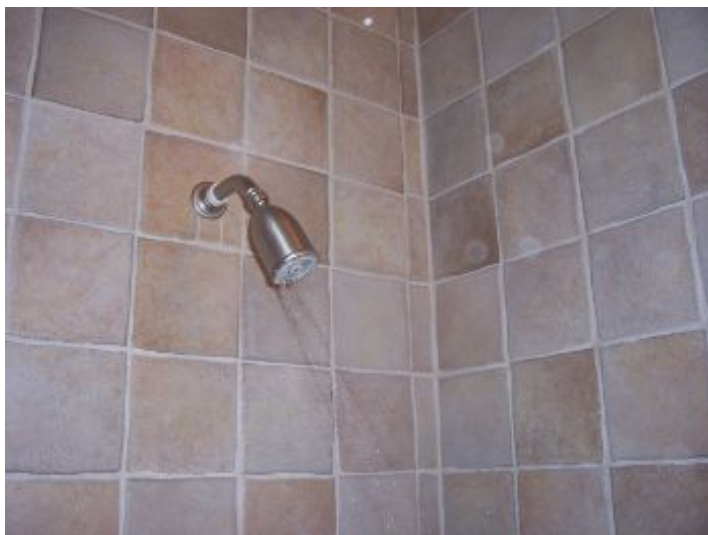
clogged shower head

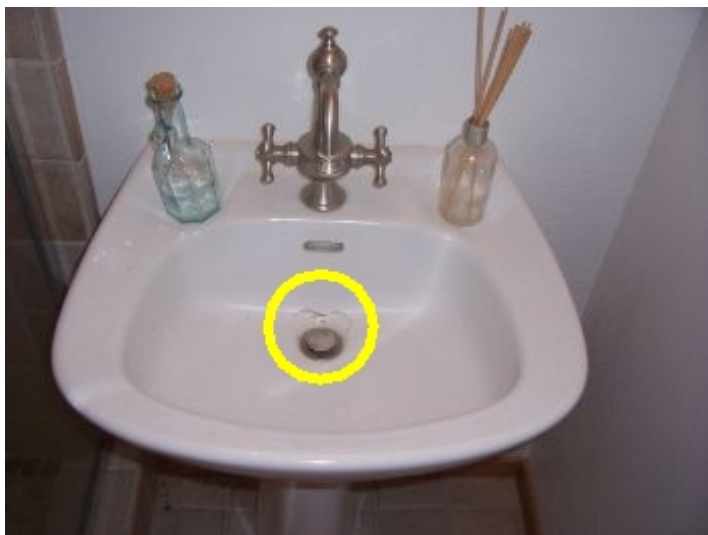
Sink is cracked around stopper area.

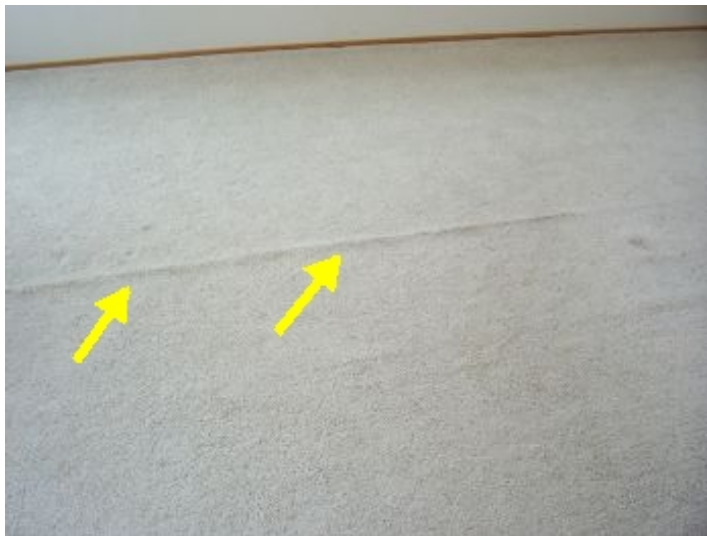
Observations: Flooring shows signs of normal wear, Master Bedroom carpet is loose. Sub floor squeaks by closet and bath area. Recommend adding screws to sub floor at time of carpet replacement or carpet stretching in order to minimize squeaks.

loose carpet

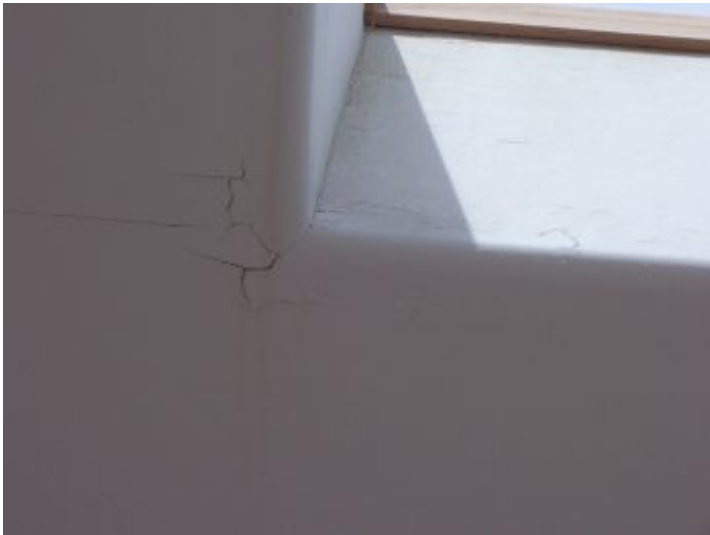
Master Bedroom loft ceiling at sky lights appear to have a leak.

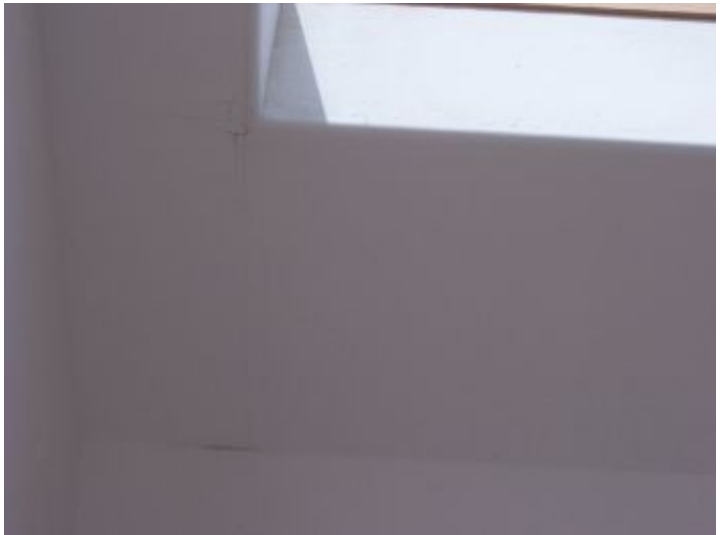
master bedroom ceiling water leak

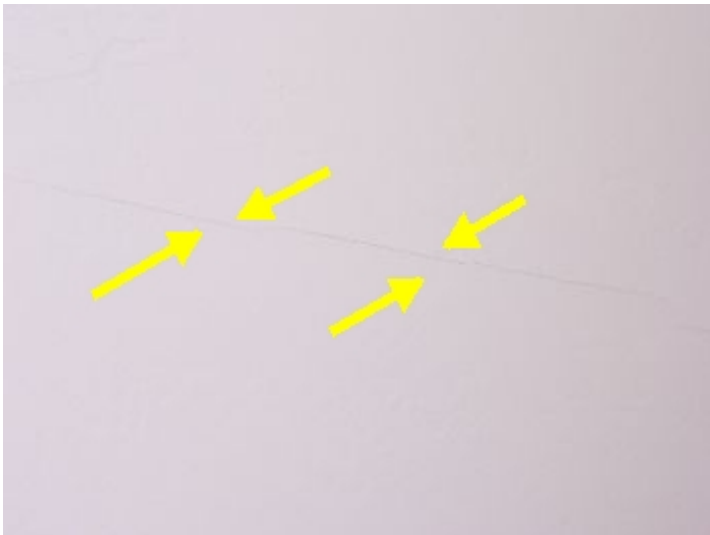
crack in master bedroom ceiling

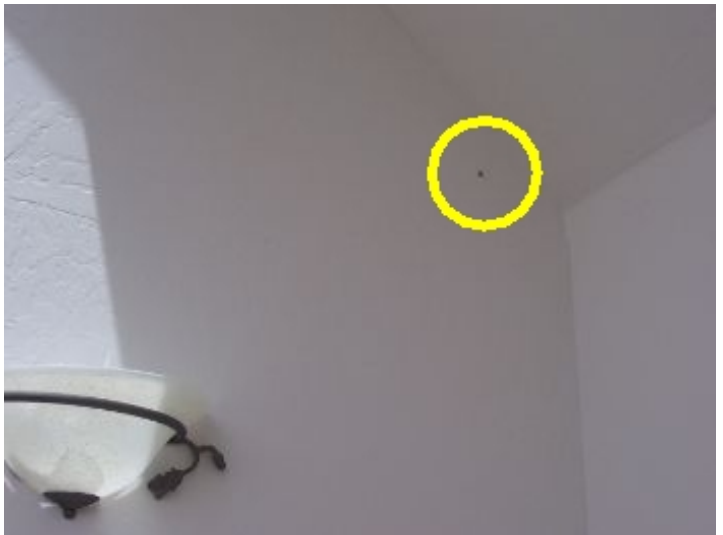
master bedroom stair way has a nail pop

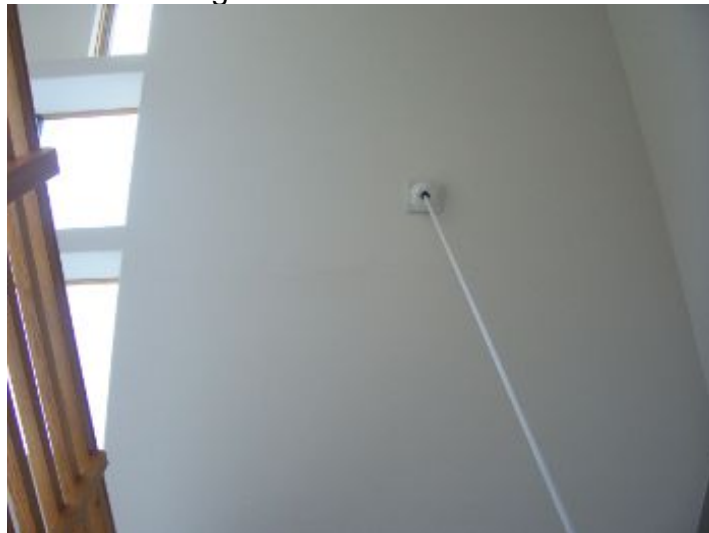
crack in ceiling of master bedroom

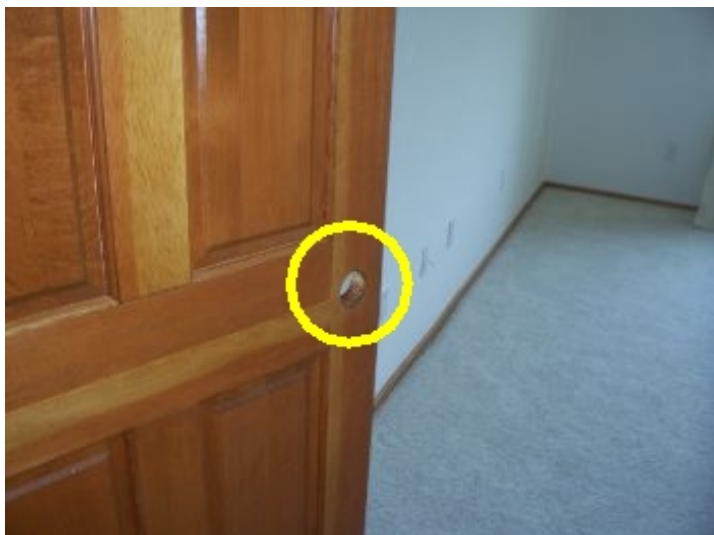
Bedroom #2 is missing door knob and striker plate on utility door.

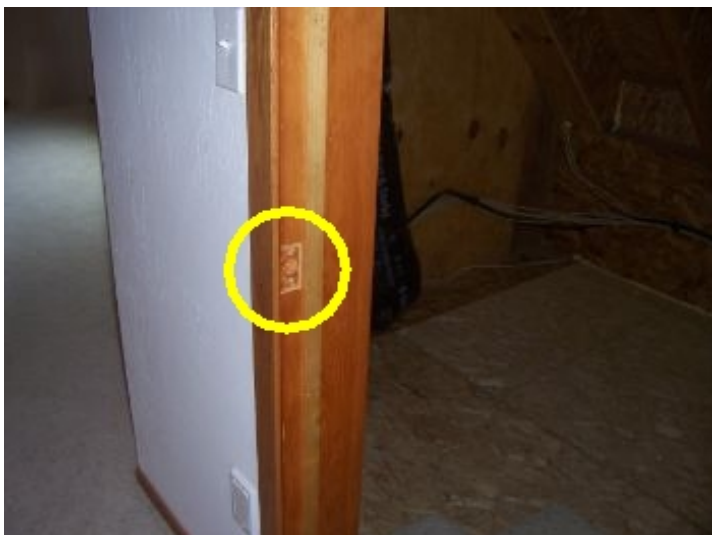
missing striker plate

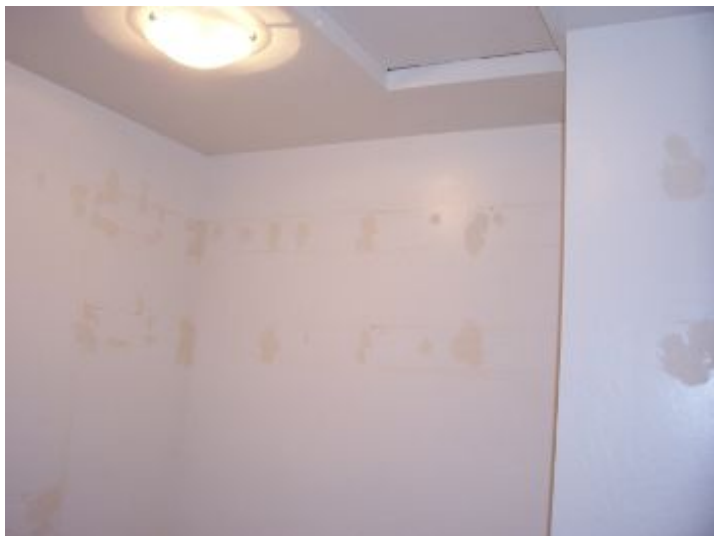
missing shelving

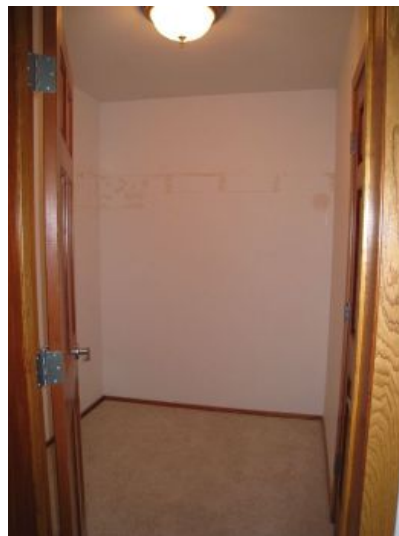
master closet missing shelf and pole

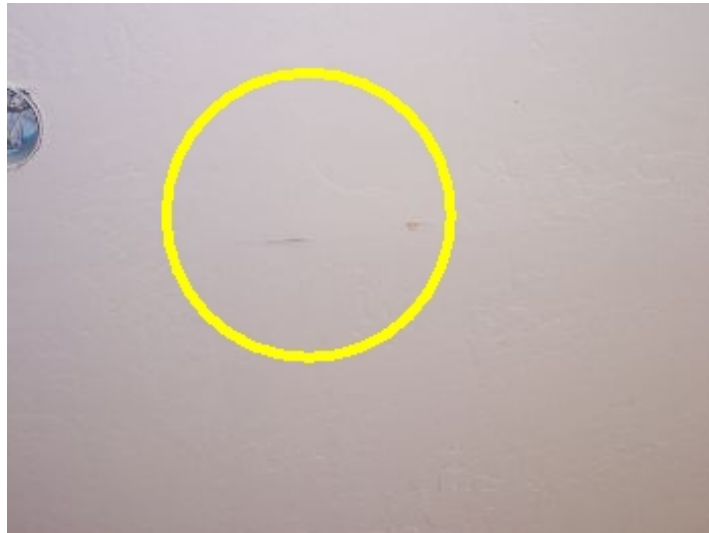
Evidence of past water penetration observed at ceiling in dining area under upper exterior wall.

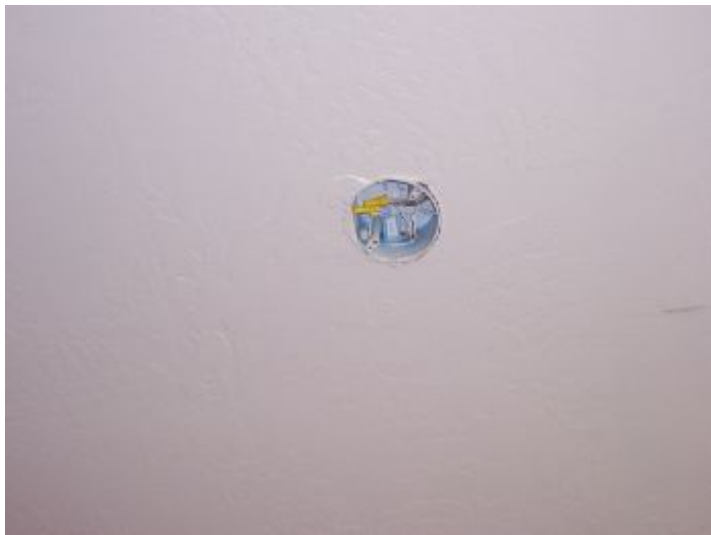
missing dinig light

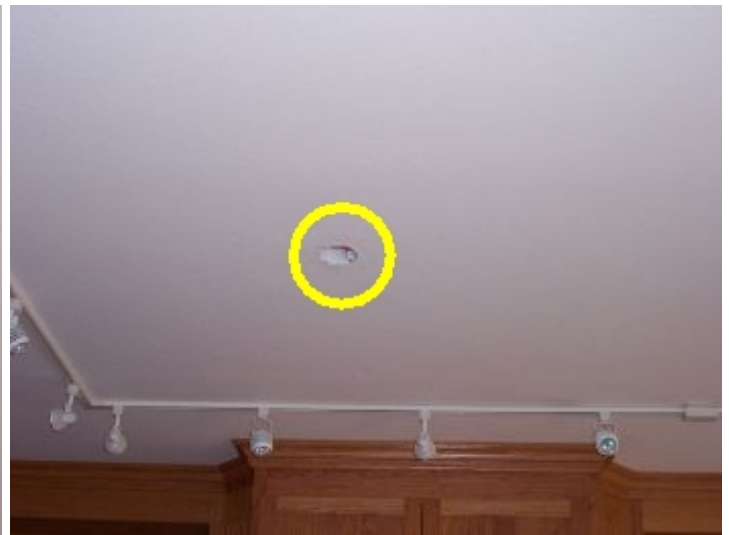
Office light missing

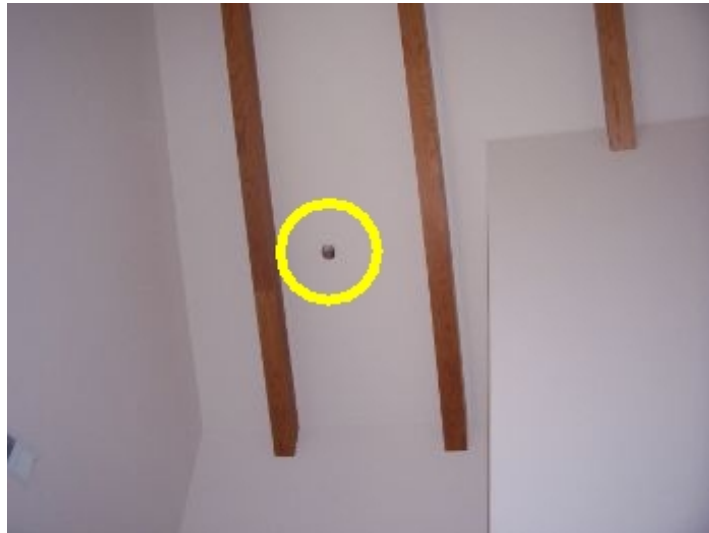
entry light missing

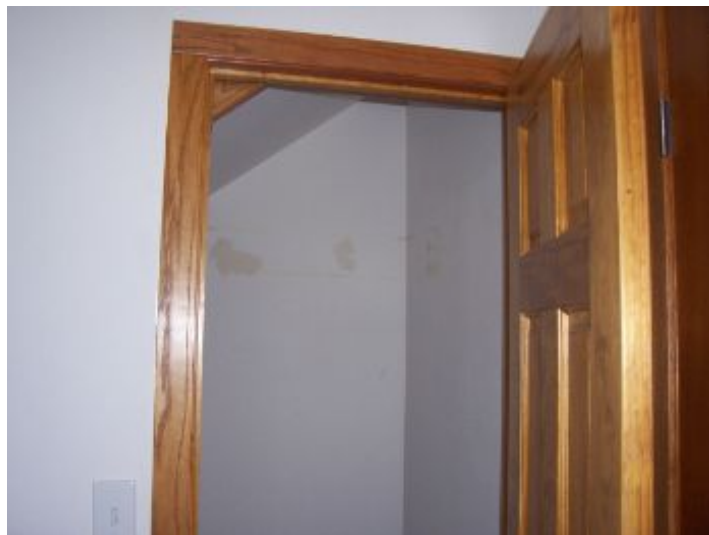
entry closet missing shelf and pole

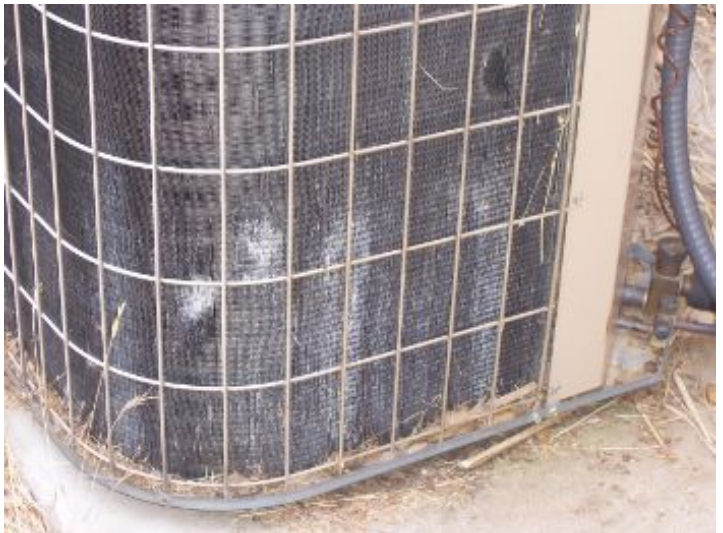
Observations: At time of Inspection AC condenser appeared to be operating satisfactory., cooling fins are showing signs of deterioration., Recommend HVAC contractor to evaluate and service units.

starting to deteriorate
