McKee Home Inspection Services

Property Inspection Report

28885 Buck Owens blvd, Bakersfield CA, 93308
Inspection prepared for: Buck Owens
Agent: -

Inspection Date: 6/12/2009 Time: 10:00 am
Age: 8 years old Size: 3800 s.f.
Weather: about 95 deg

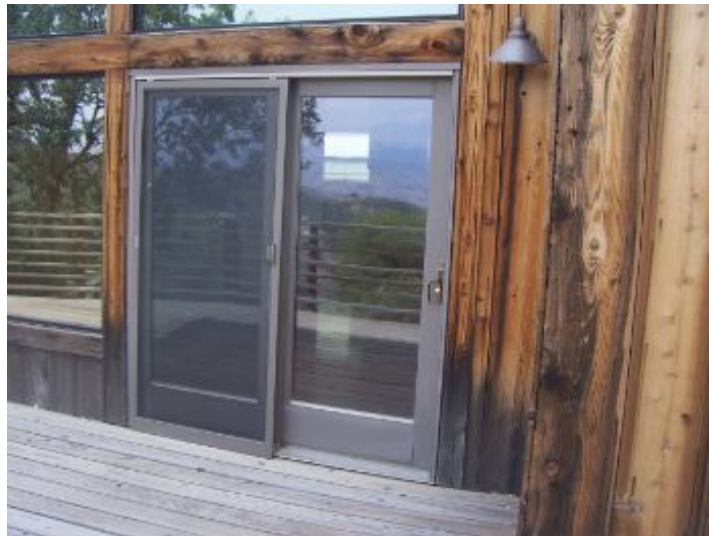
- Front door needs a protective coat of varnish.
- Front door needs an adjustment, latch and striker plate rub.
- Metal clad on the out side at the bottom of the sliding door south of fireplace is coming loose.

metal clad coming loose

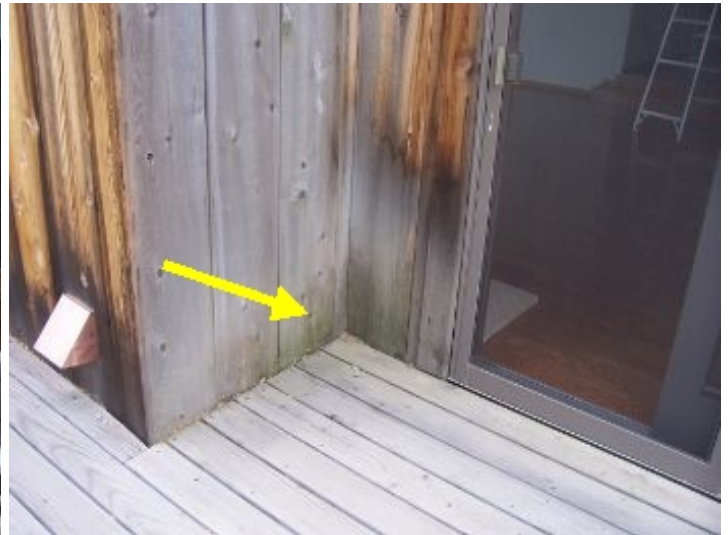
weathered siding

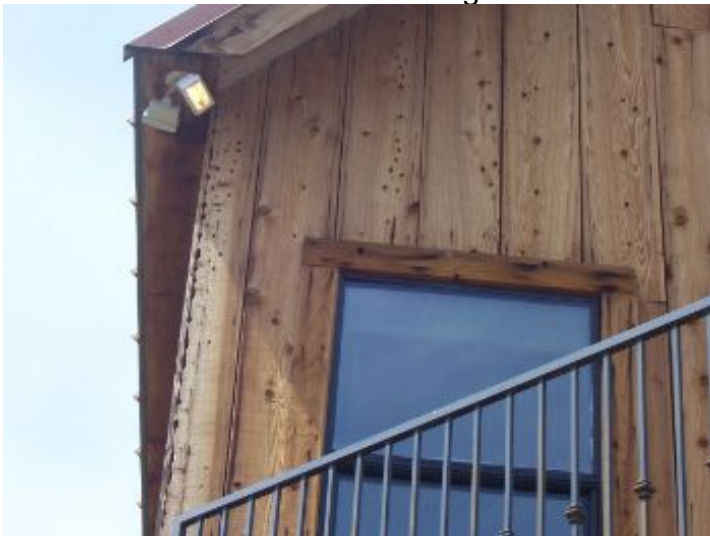
Observations: Stone Veneer is coming off at various locations on the house. Recommend re-attaching all loose and fallen stones as needed, by a qualified licensed contractor. , Cedar siding has numerous wood pecker holes throughout, loose in many places around the house and overhang. Recommend replacement or repair by a qualified licensed contractor.

wood pecker holes

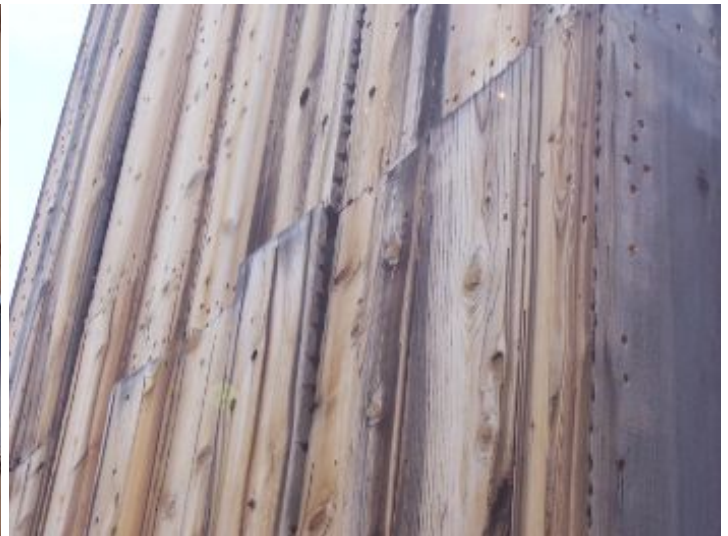
wood pecker holes

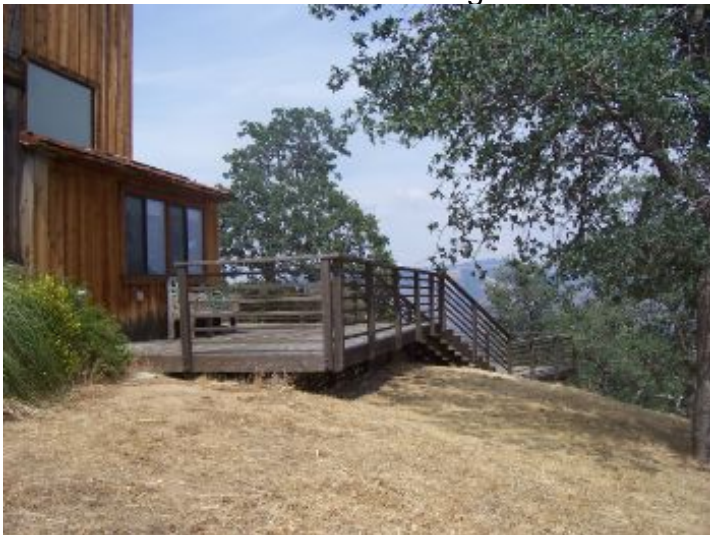
stairs need support

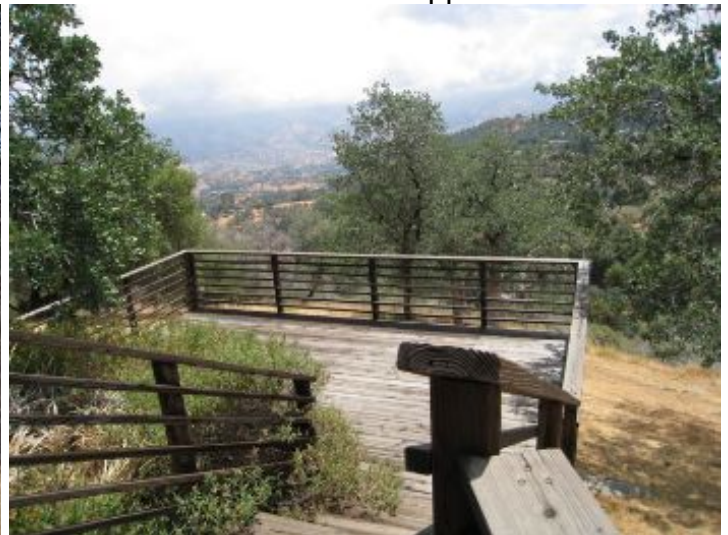
remove vegetation and dirt away from deck

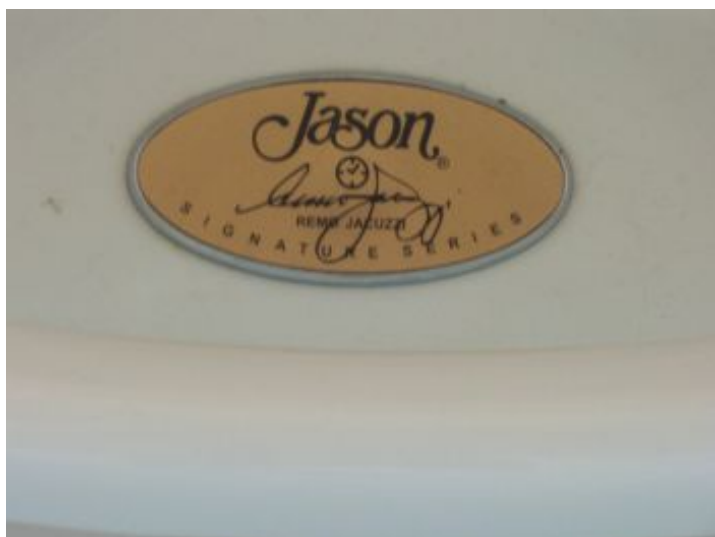
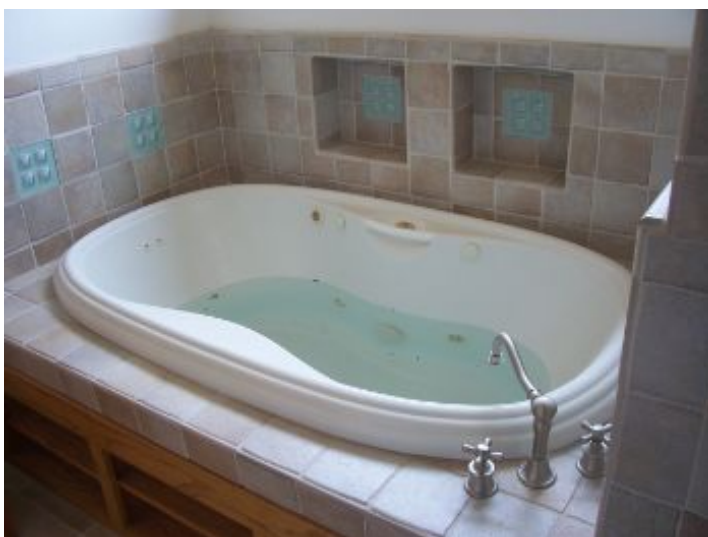
[Refer to \[www.kohler.com\]\(http://www.kohler.com\) for excellent information on whirlpool tub operation and maintenance.](#) • [Jetted tub](#) was filled to a level above the water jets and did not operated by normal controls. Pump and supply lines are not accessible and were not inspected.

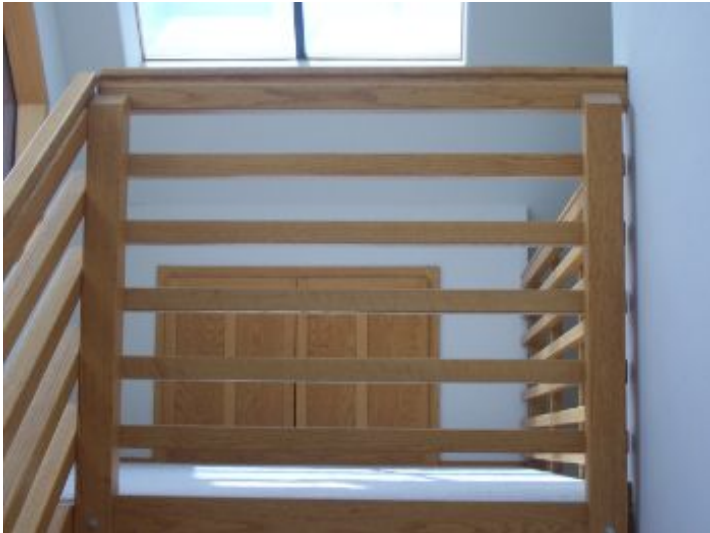
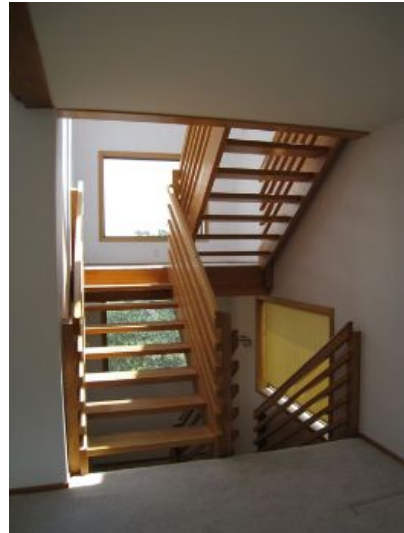
- Stairway(s) appears to be functioning Properly. There are no concerns.
- SAFETY NOTE: The opening between Balusters (vertical posts comprising barrier in railings) was observed to be 6 inches. A toddler can very easily fall through this spacing from landing to floor below. Although 6" spacing was adequate when home was built -- modern building safety standard is now a maximum of 4" between balusters.

stairway to loft from master bedroom

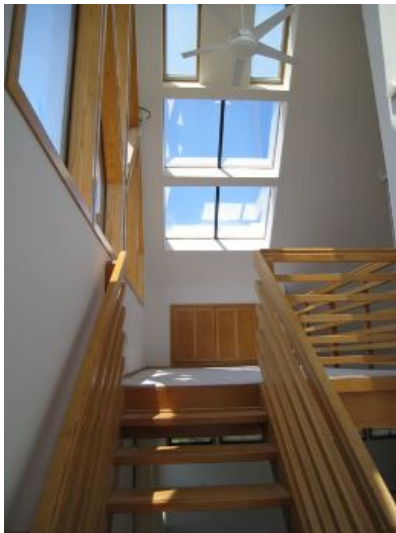
stairs and hand rail to loft

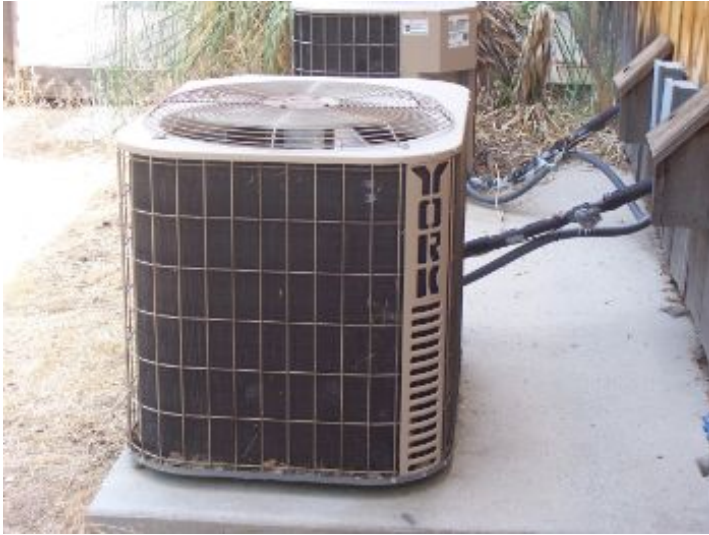
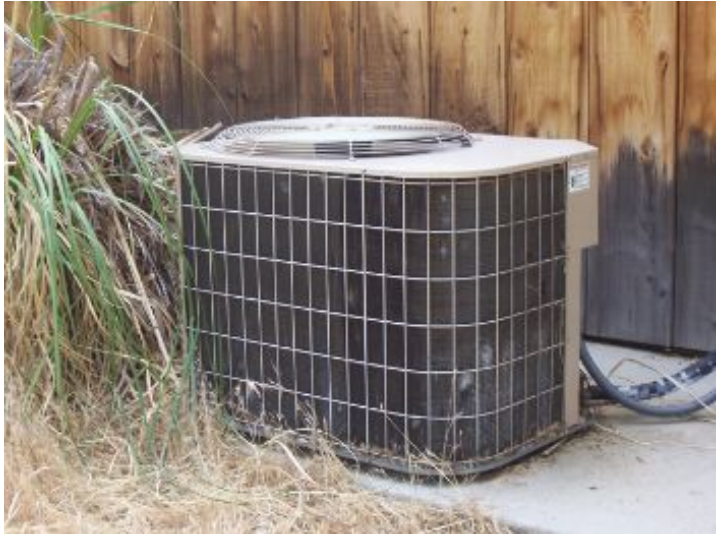
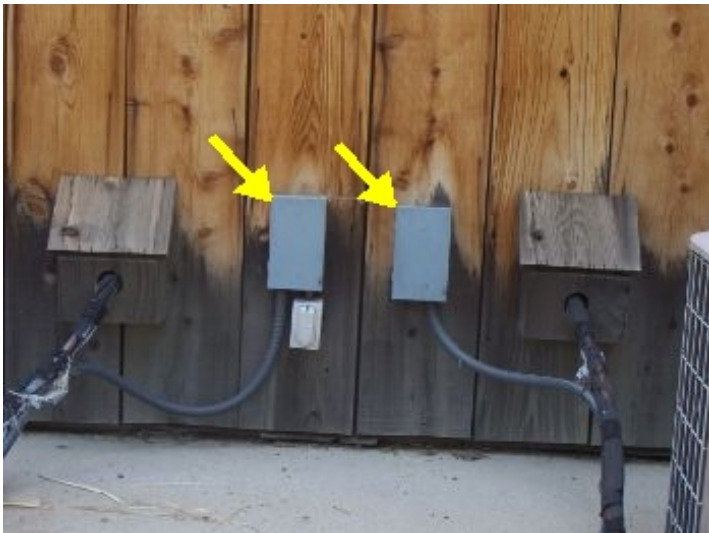
power disconnects for AC condensers

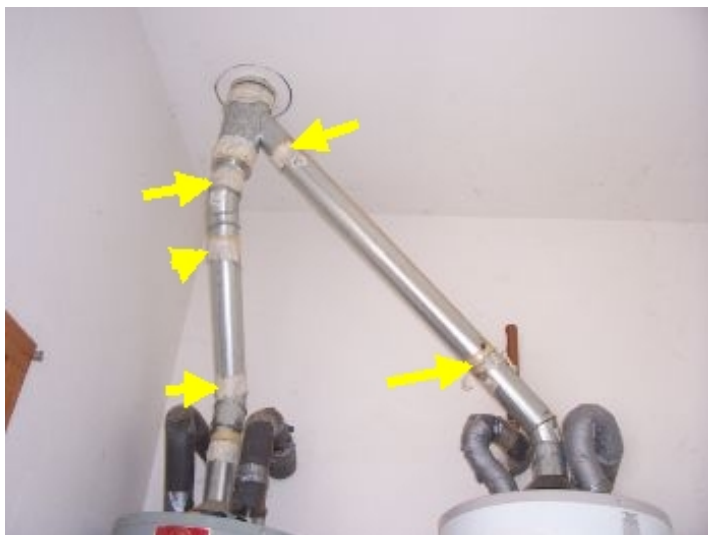
wrong type of tape on vent pipes

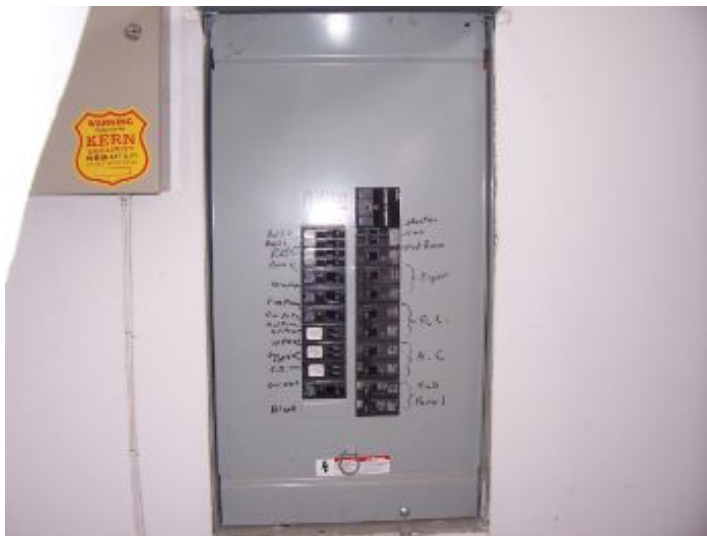
Electric panel appears to be serviceable at time of inspection.
